Kearl Drainage Pond 4 (DP4) Overflow – Investigation Results

May 5, 2023

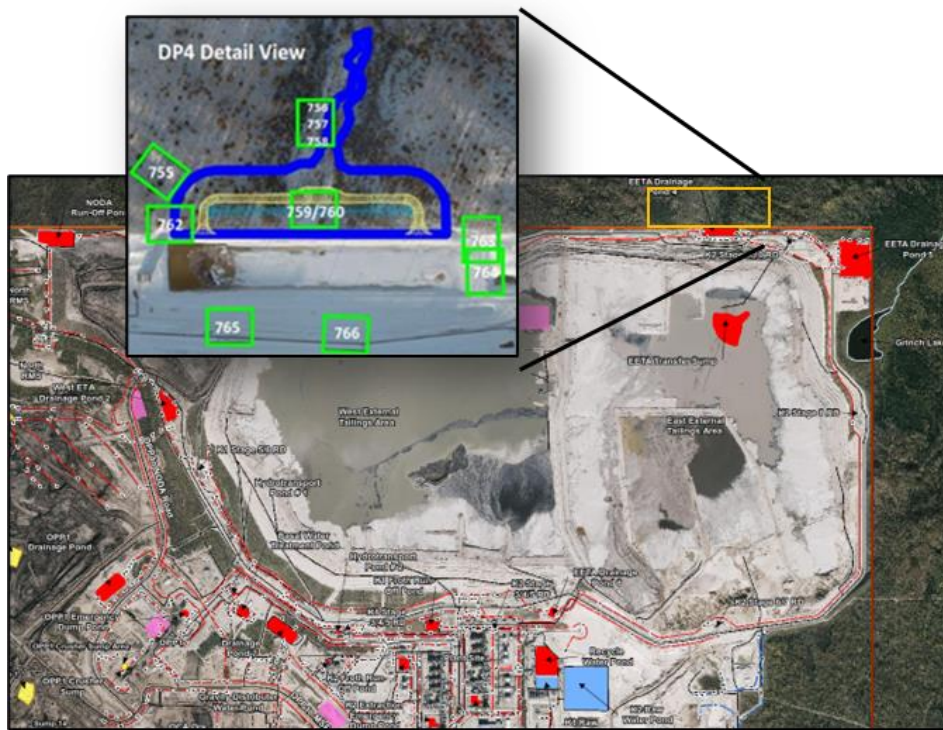
DP4 Release Area

Between January 30th and January 31st, 2023, an estimated 5300m3 of water flowed through the spillway of DP4. The pond is situated on the North lease boundary for Kearl and consequently the released fluids flowed to both on and off lease areas following the natural topography of the area. The release was discovered on February 4th when impacted snow was observed, indicating that fluids had overflowed the pond via the existing overflow spillway and flowed north towards the Kearl lease boundary.
