**Re: Annual Flowline Integrity and Break Up Report  
Water Licence S13L1-007, Part F, Condition 6  
Imperial Oil Resources N.W.T. Limited (Imperial)**

# Norman Wells Operations Annual Flowline Integrity and Break-Up Report

October 2016

**Imperial Oil Resources N.W.T. Limited**  
Bag 5000, 1001 Canol Drive  
Norman Wells, Northwest Territories  
X0E 0V0, Canada

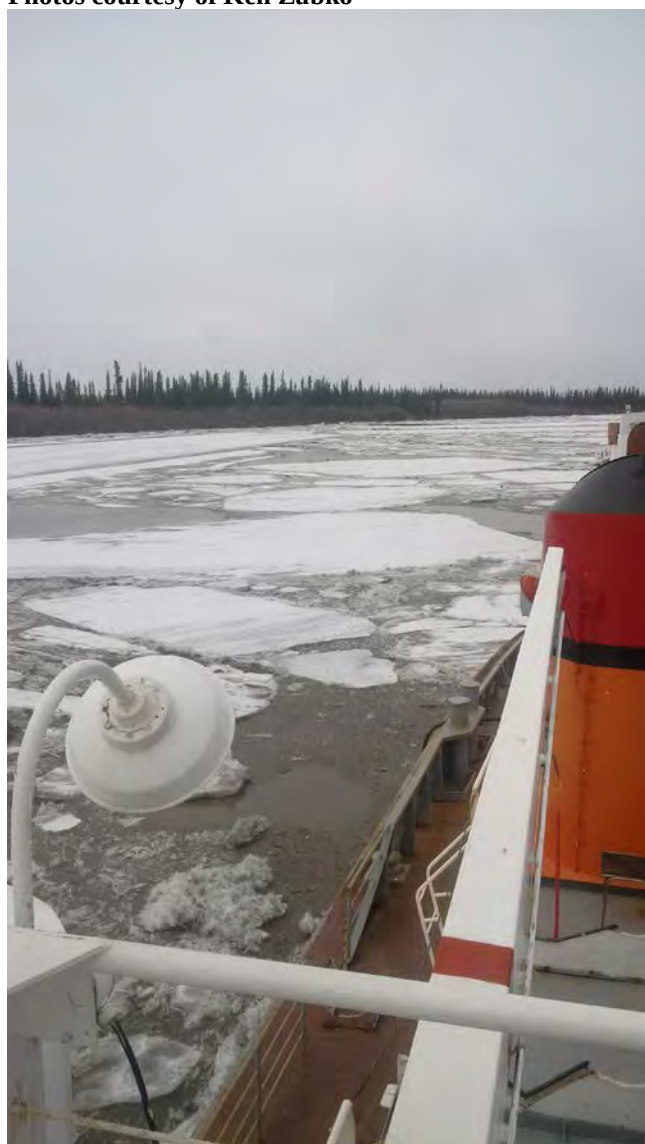
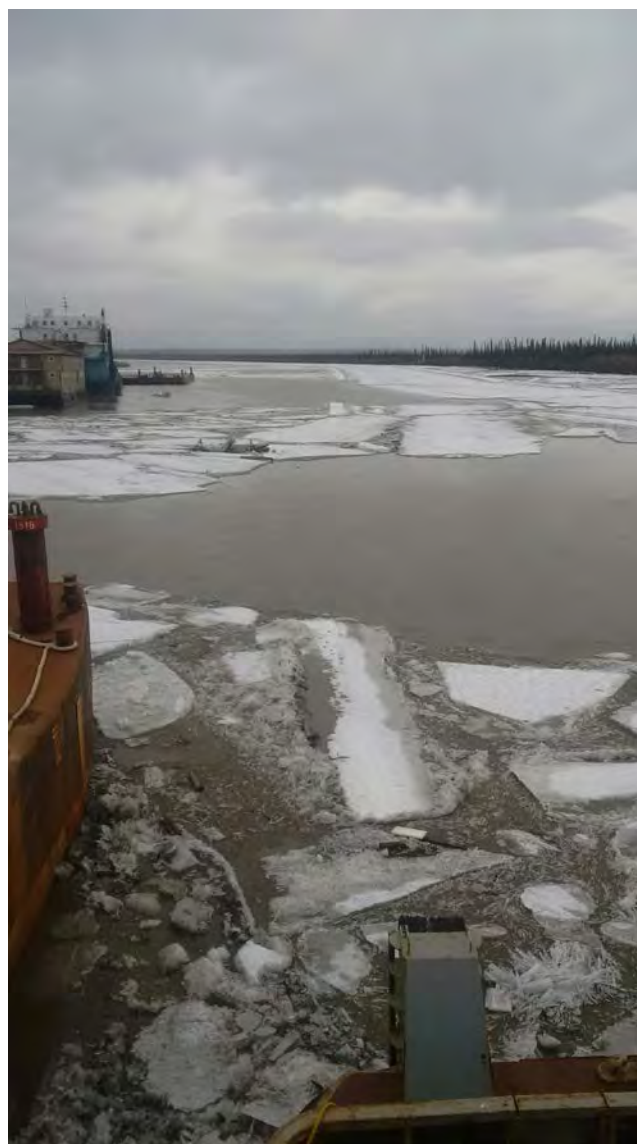
**Mackenzie River (East Channel) at Inuvik – Photo taken May 16, 2016**

**Mackenzie River (East Channel) at Inuvik (10LC002)** - Current water level is 14.651m. Average breakup level is between 12-14m occurring between May 20<sup>th</sup> and 25<sup>th</sup>. See photos of ice conditions from yesterday evening at the end of this report.

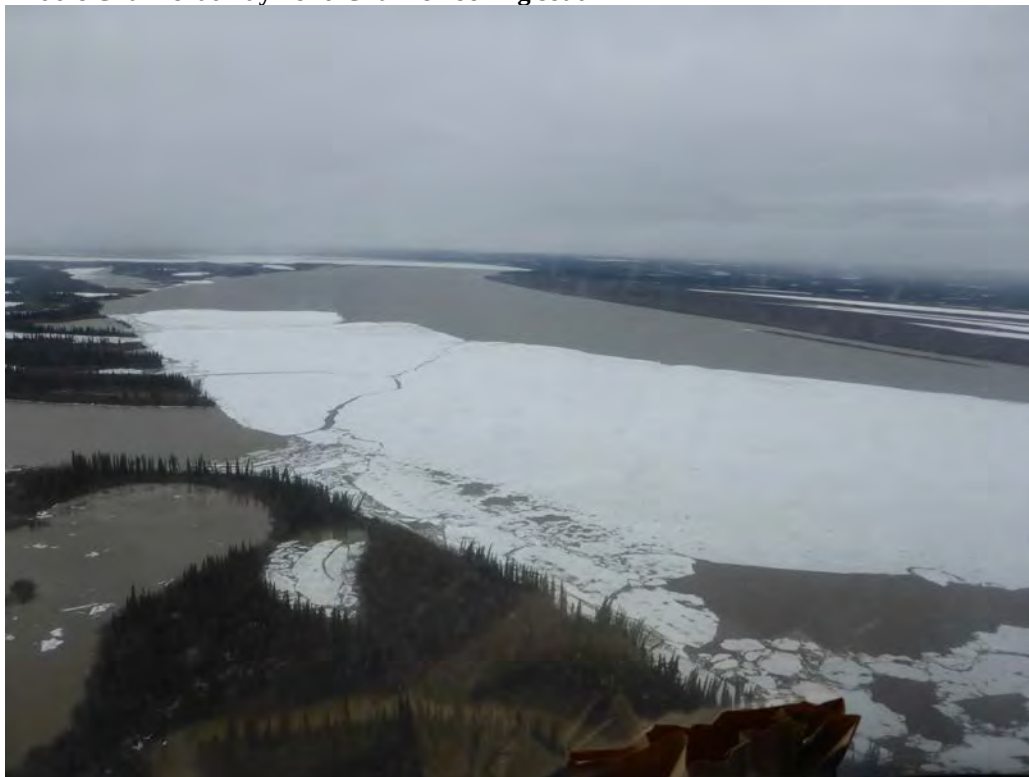
**Middle Channel at Raymond Channel looking south**

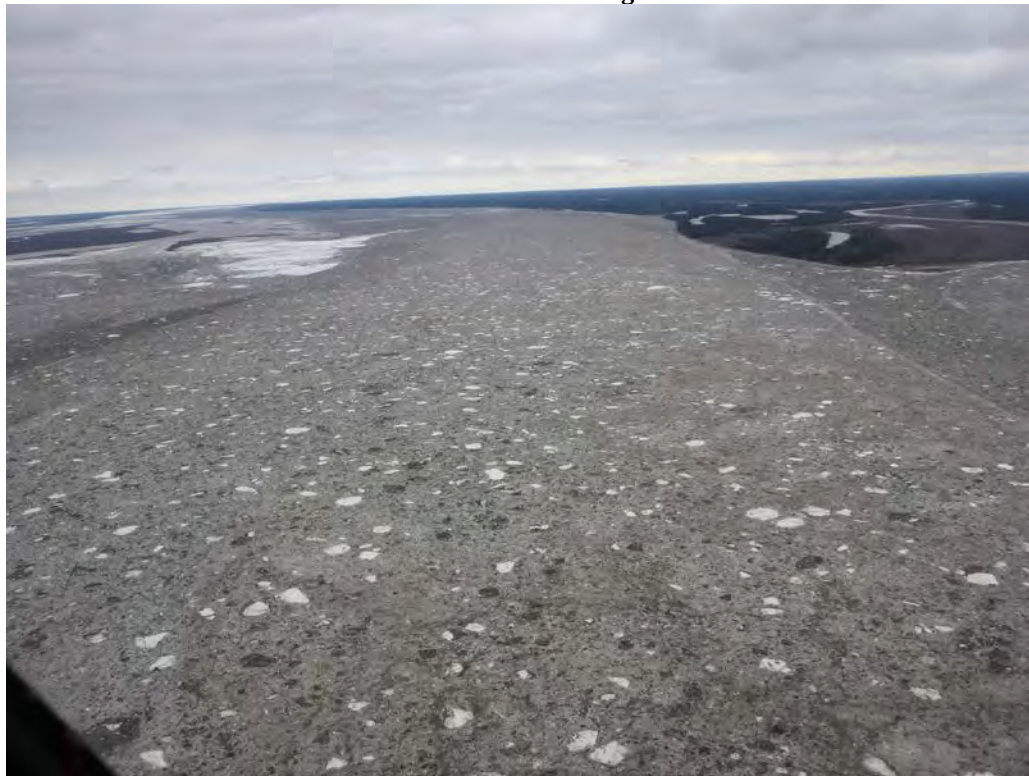
**Middle Channel at Confluence of East Channel looking downstream**

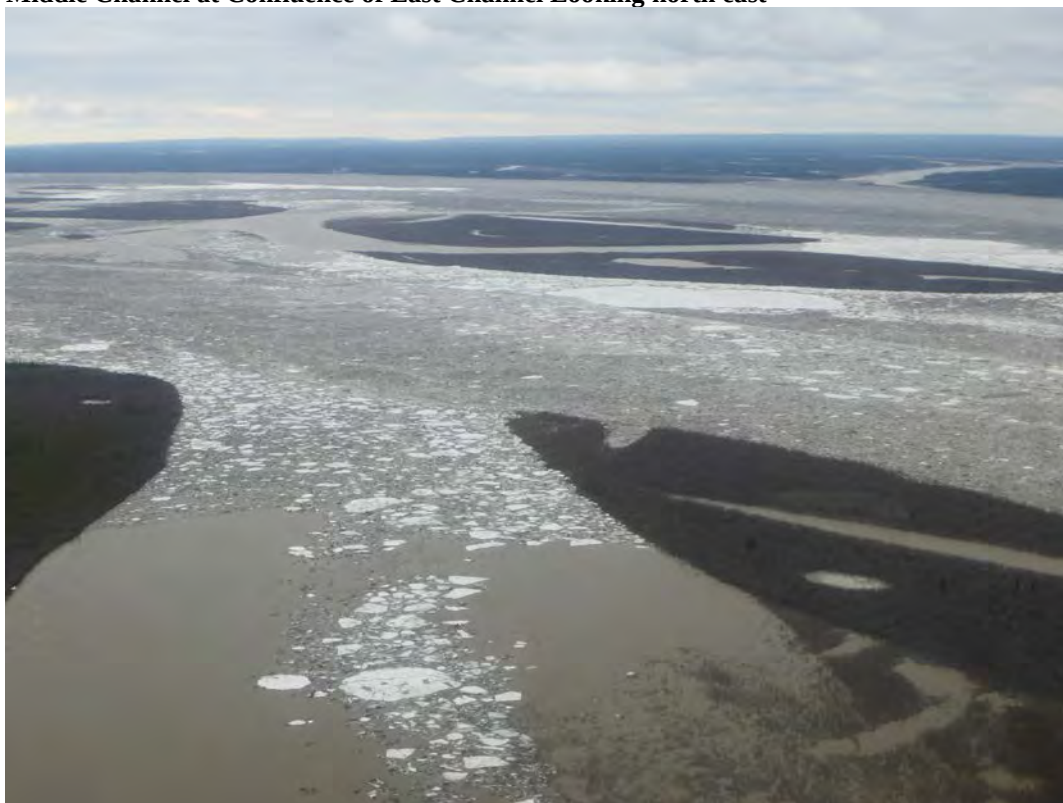
**Middle Channel at Confluence of East Channel Looking north east**

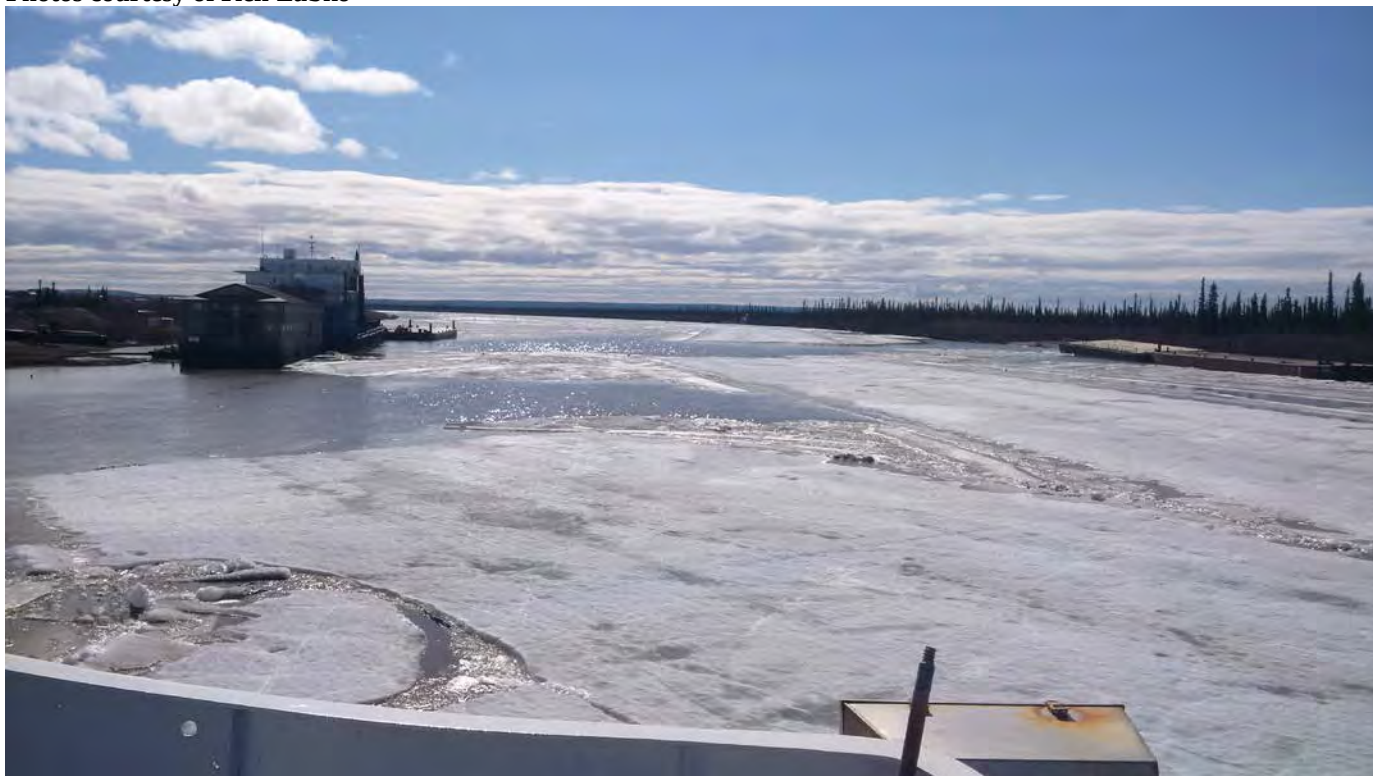
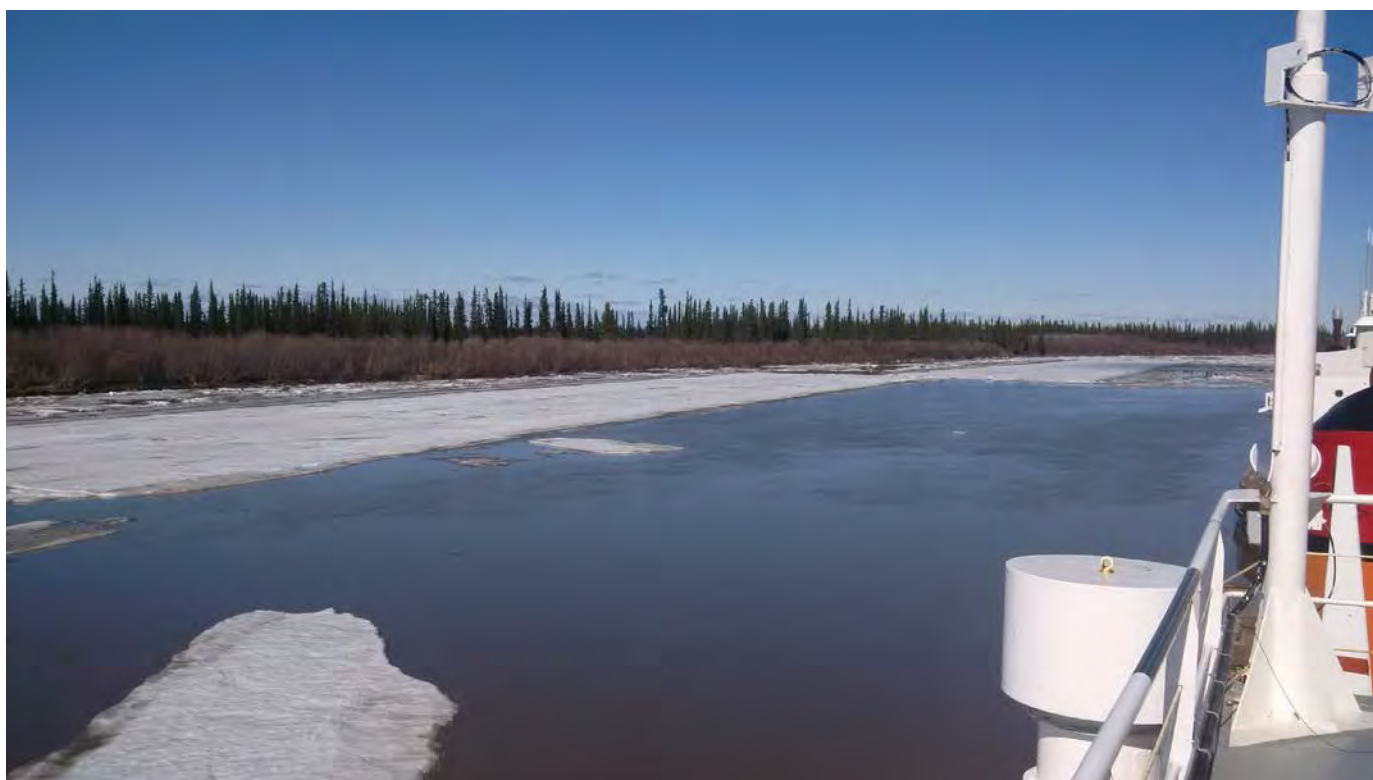
**Mackenzie River (East Channel) at Inuvik – Photo taken May 18, 2016**

**Mackenzie River (East Channel) at Inuvik (10LC002) - Current water level is 14.922m. Average breakup level is between 12-14m occurring between May 20<sup>th</sup> and 25<sup>th</sup>. See photos of ice conditions from yesterday afternoon at the end of this report.**

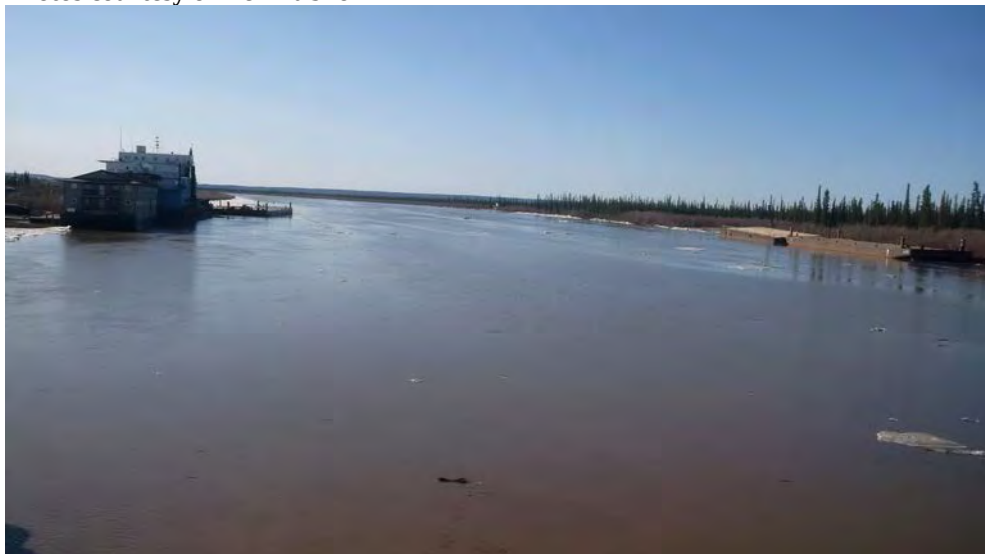
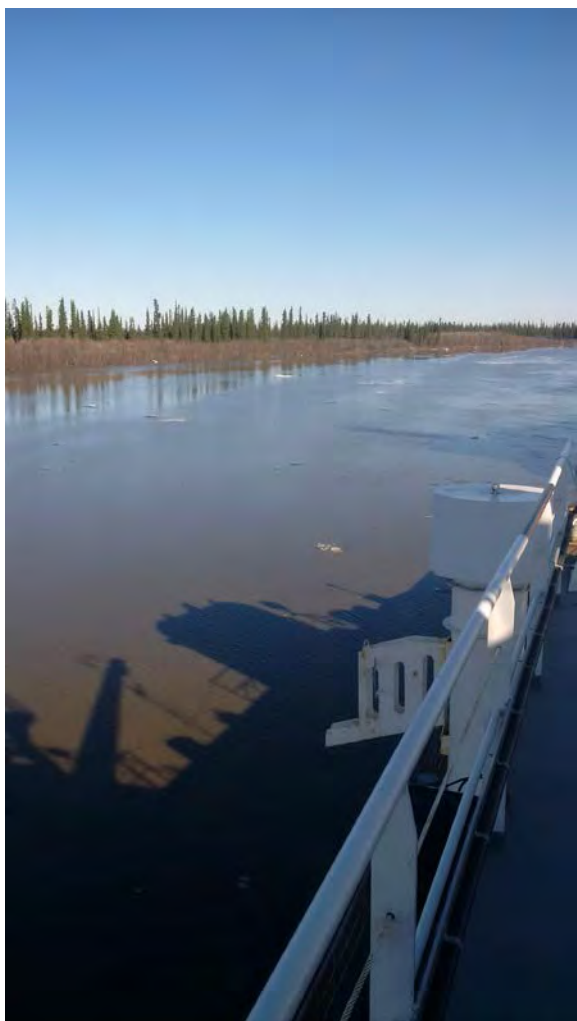
## **Mackenzie River (East Channel) at Inuvik – Photos taken May 20, 2016**

**Mackenzie River (East Channel) at Inuvik (10LC002) - Current water level is 15.099m. Average breakup level is between 12-14m occurring between May 20<sup>th</sup> and 25<sup>th</sup>. Please see the end of this report for photos of current ice conditions as of this morning.**

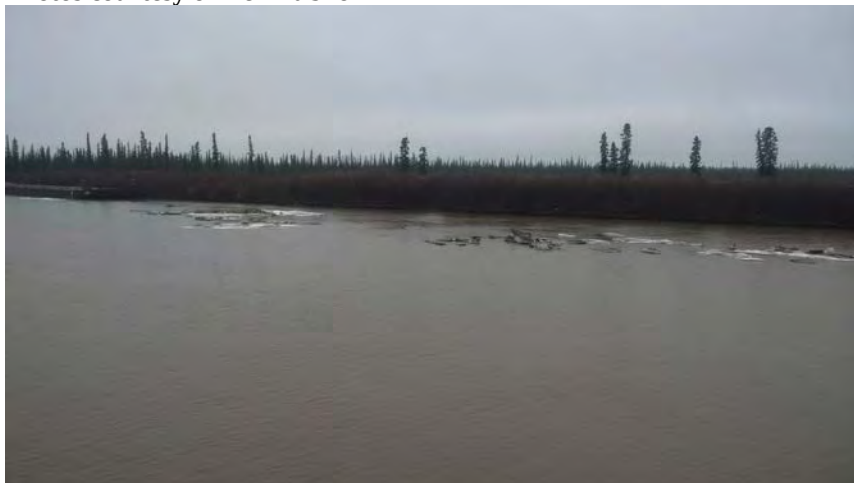
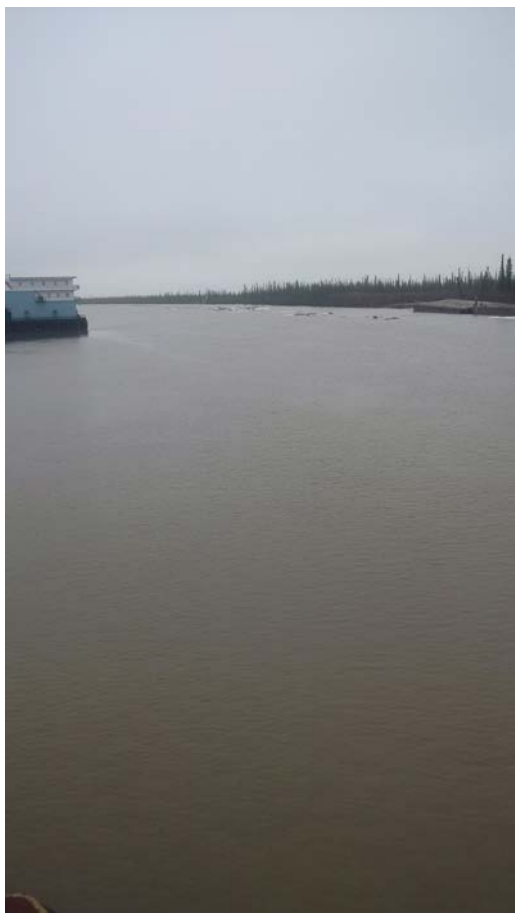
**Mackenzie River (East Channel) at Inuvik – Photos taken May 23, 2016**

**Mackenzie River (East Channel) at Inuvik (10LC002)** - Current water level is 14.579m. Average breakup level is between 12-14m occurring between May 20<sup>th</sup> and 25<sup>th</sup>. Please see the end of this report for photos of river conditions yesterday.

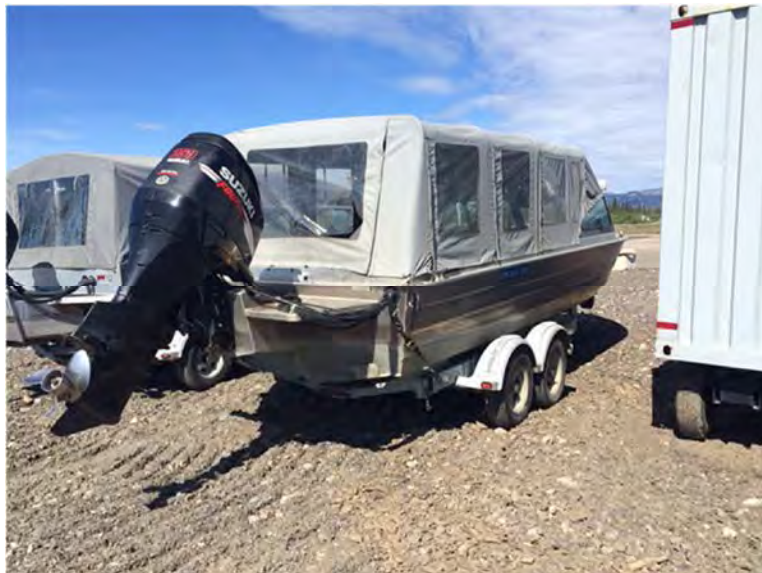
The survey launches and boat captains for this project were supplied by Imperial. The primary launch (Boat 1) is a 7.3 m aluminum vessel equipped with a 250 hp, 4 stroke Suzuki motor equipped with a propeller (Image J).

**Image J: Primary Survey Vessel (Imperial Boat 1)**

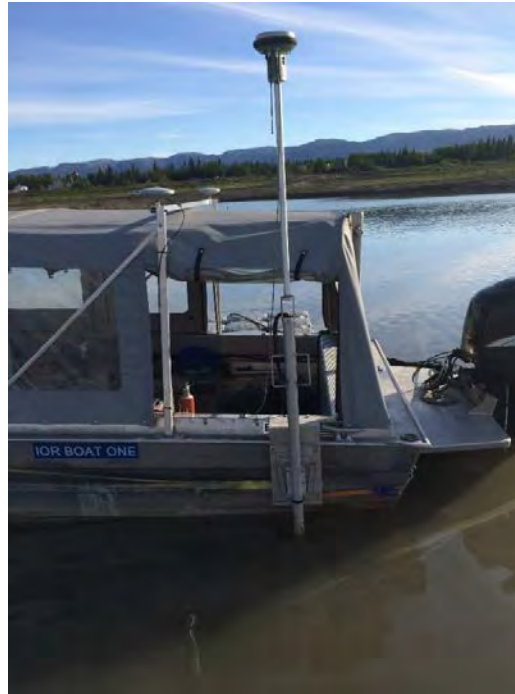
The survey launch was equipped with the required survey gear and all instruments were interfaced into a central control platform running Hypack navigation and control software (Image K and L).

**Image K: Survey Gear**

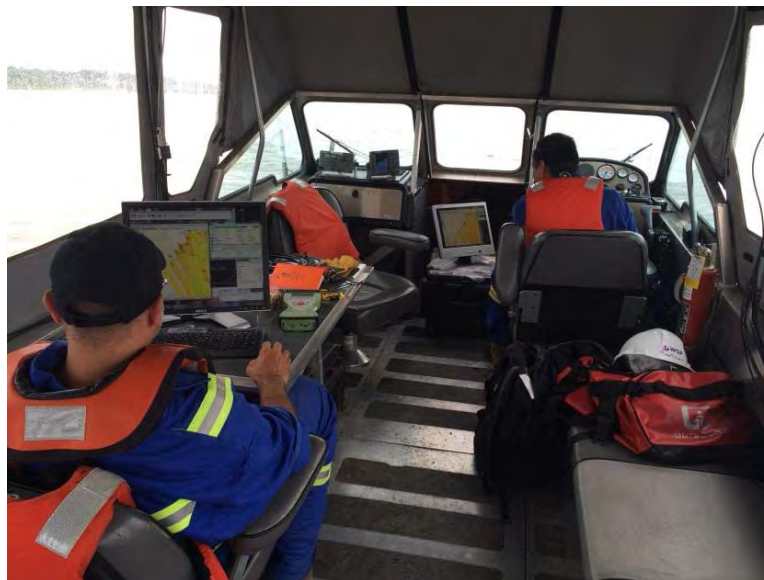
**Image L: Survey Gear Inside of Boat 1**

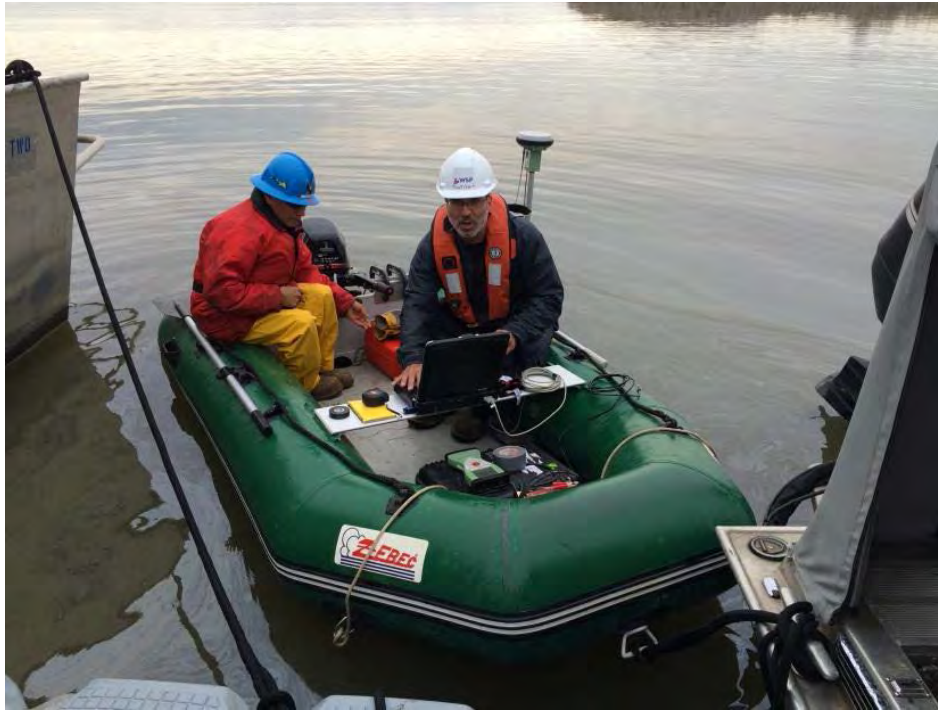
In order to survey the river bottom in the shallower water areas between Goose Island, Artificial Islands 3 and 4, and between Bear Island and Island 6, a shallow draft 10.5' inflatable boat was used. The small light weight vessel was well suited for the task and easily transported the WSP crew, Imperial captain, and single beam echo sounder and RTK GPS (Image M).

**Image M: 10.5' inflatable boat (Boat 2)**

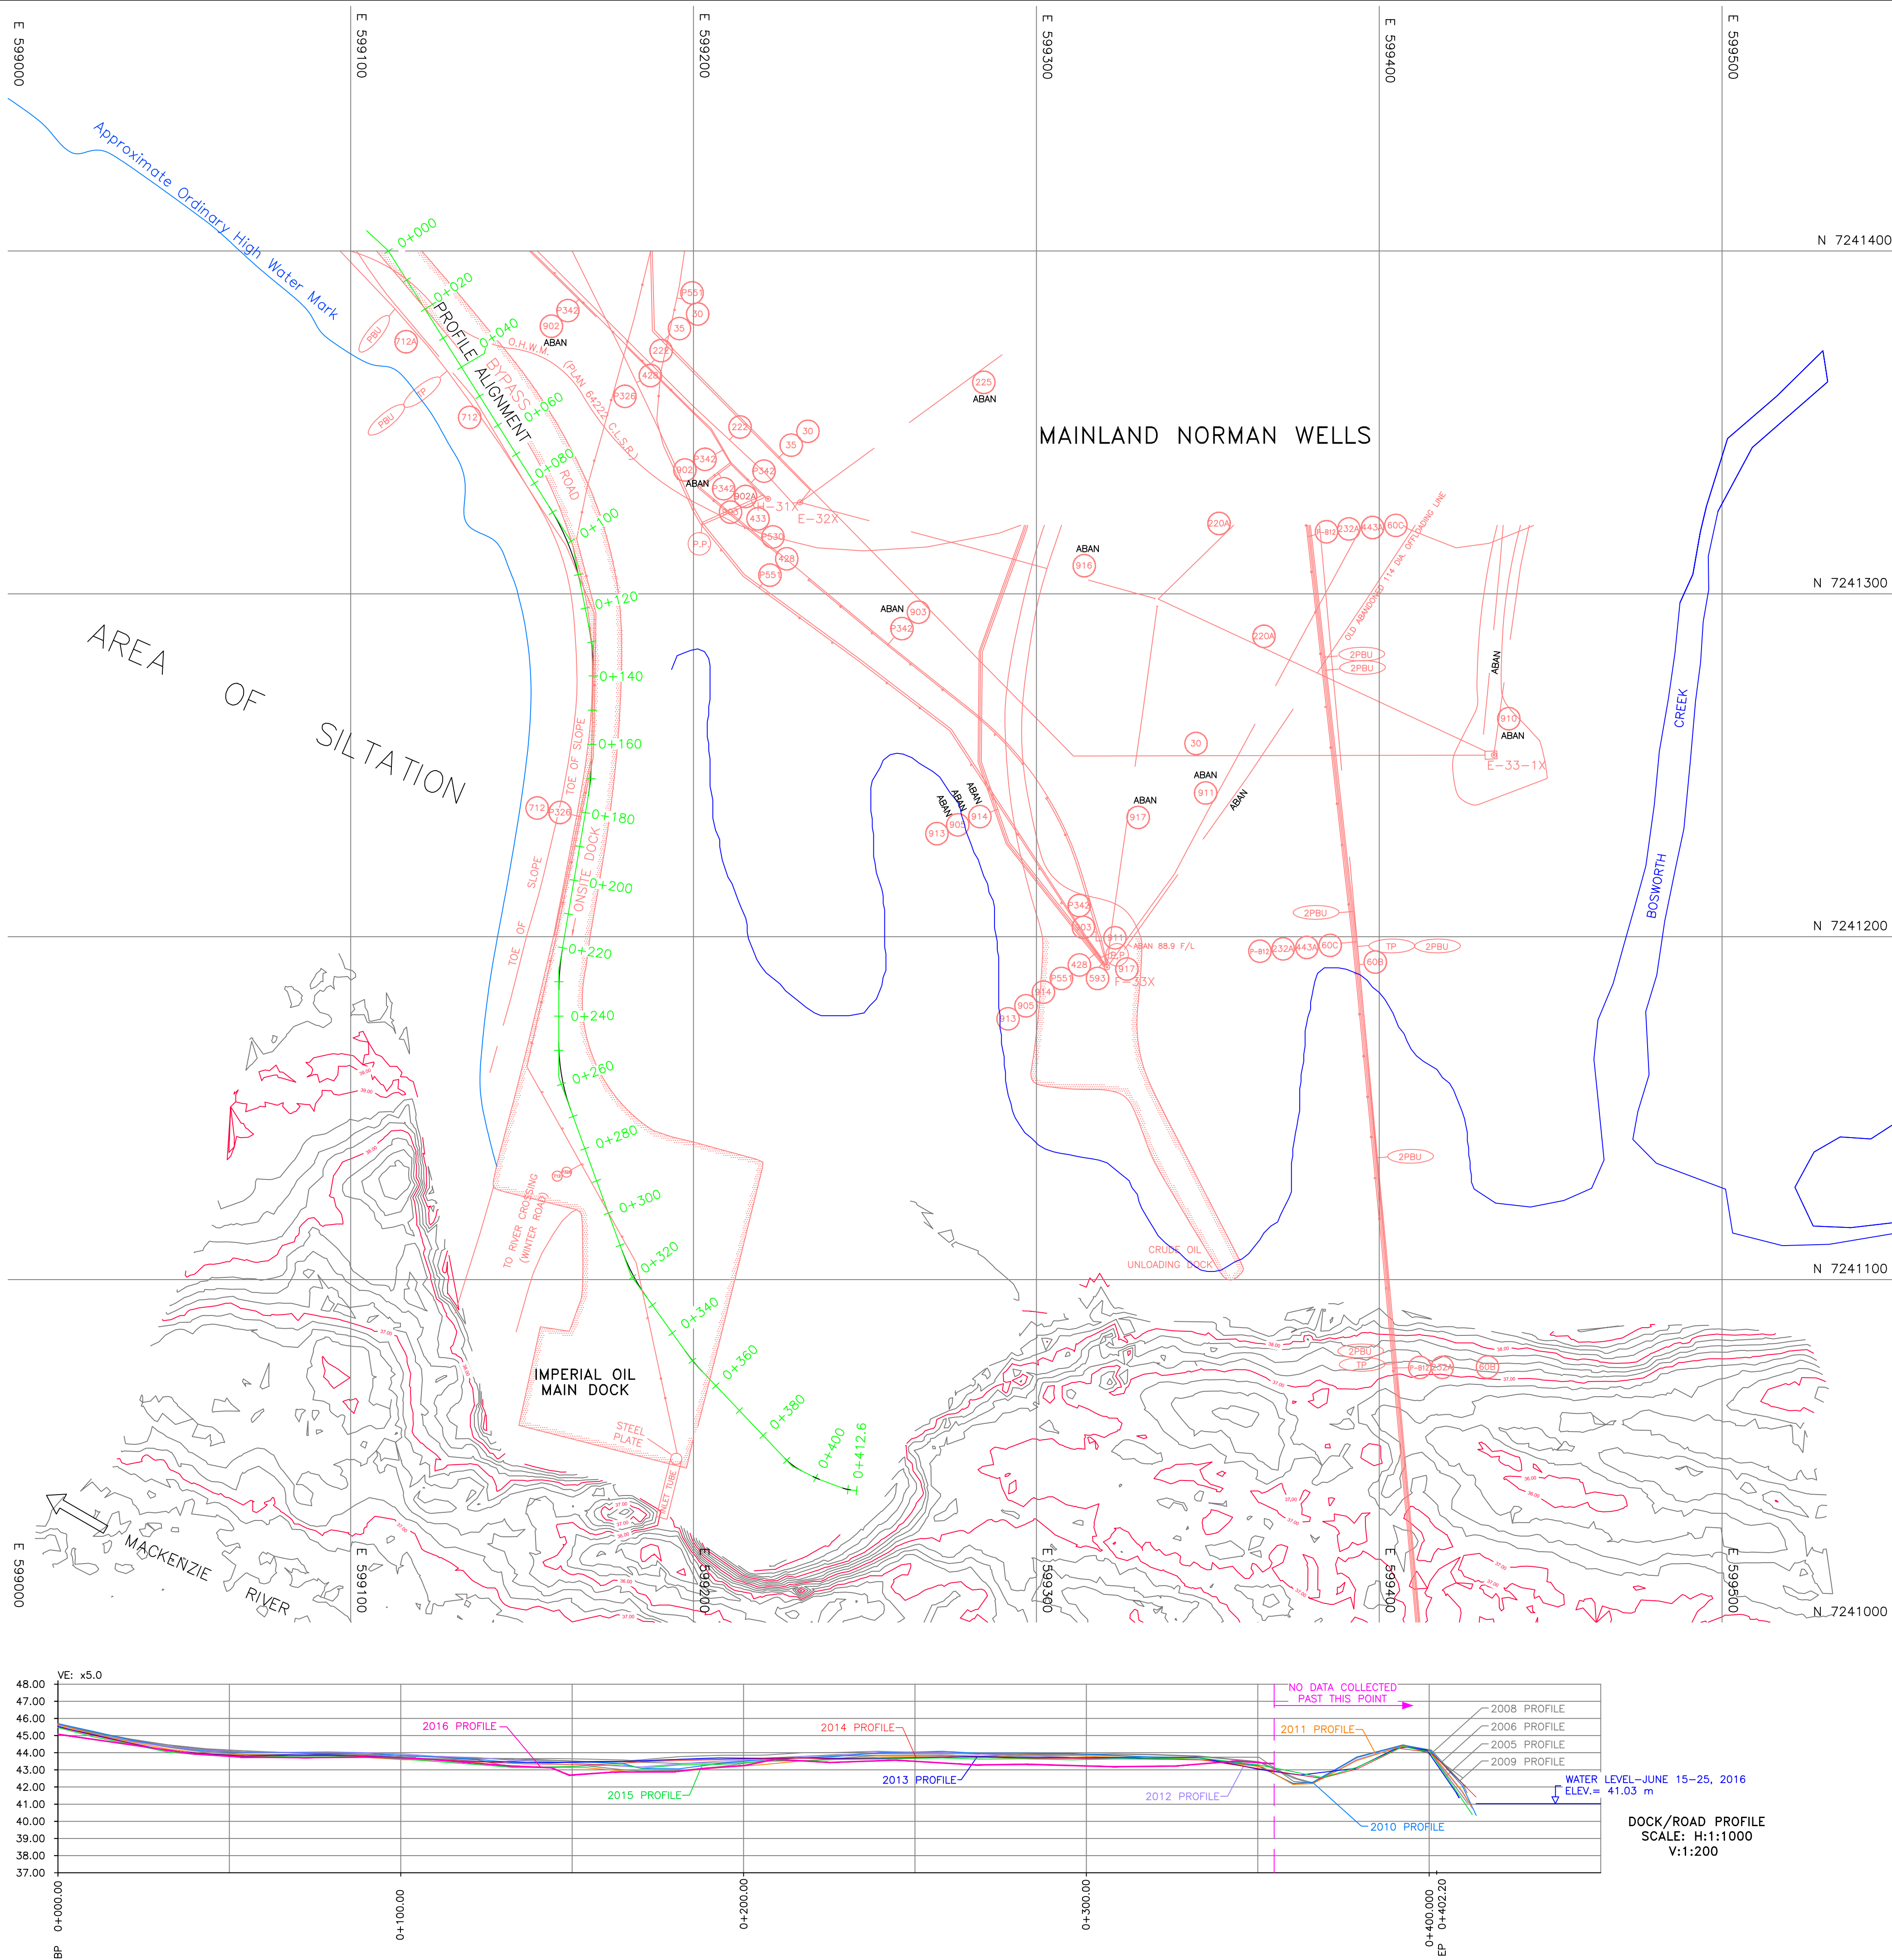
| SCALE: 1:5000 | 096-0179-700-801 86 |

1. CONTOUR INTERVAL = 0.25 METRES.
2. BATHYMETRIC SURVEY PERFORMED BETWEEN JUNE 15 TO JUNE 25, 2016.
3. WATER LEVEL = 41.03 m (JUNE 15–25, 2016)
4. WATER LEVEL DETERMINED DIRECTLY FROM RTK GPS OBSERVATIONS ON SURVEY VESSEL.
5. HORIZONTAL DATUM: NAD27(SHORAN)—UTM GRID/CM = 129'
6. VERTICAL DATUM: GEODETIC BM 747016 ELEVATION = 60.189m
7. PIPELINE ALIGNMENT SURVEYED BETWEEN MAY 19 TO MAY 22, 2016.
