# Norman Wells Operations Annual Flowline Integrity and Break-Up Report

October 2017

**Imperial Oil Resources N.W.T. Limited**  
Bag 5000, 1001 Canol Drive  
Norman Wells, Northwest Territories  
X0E 0V0, Canada

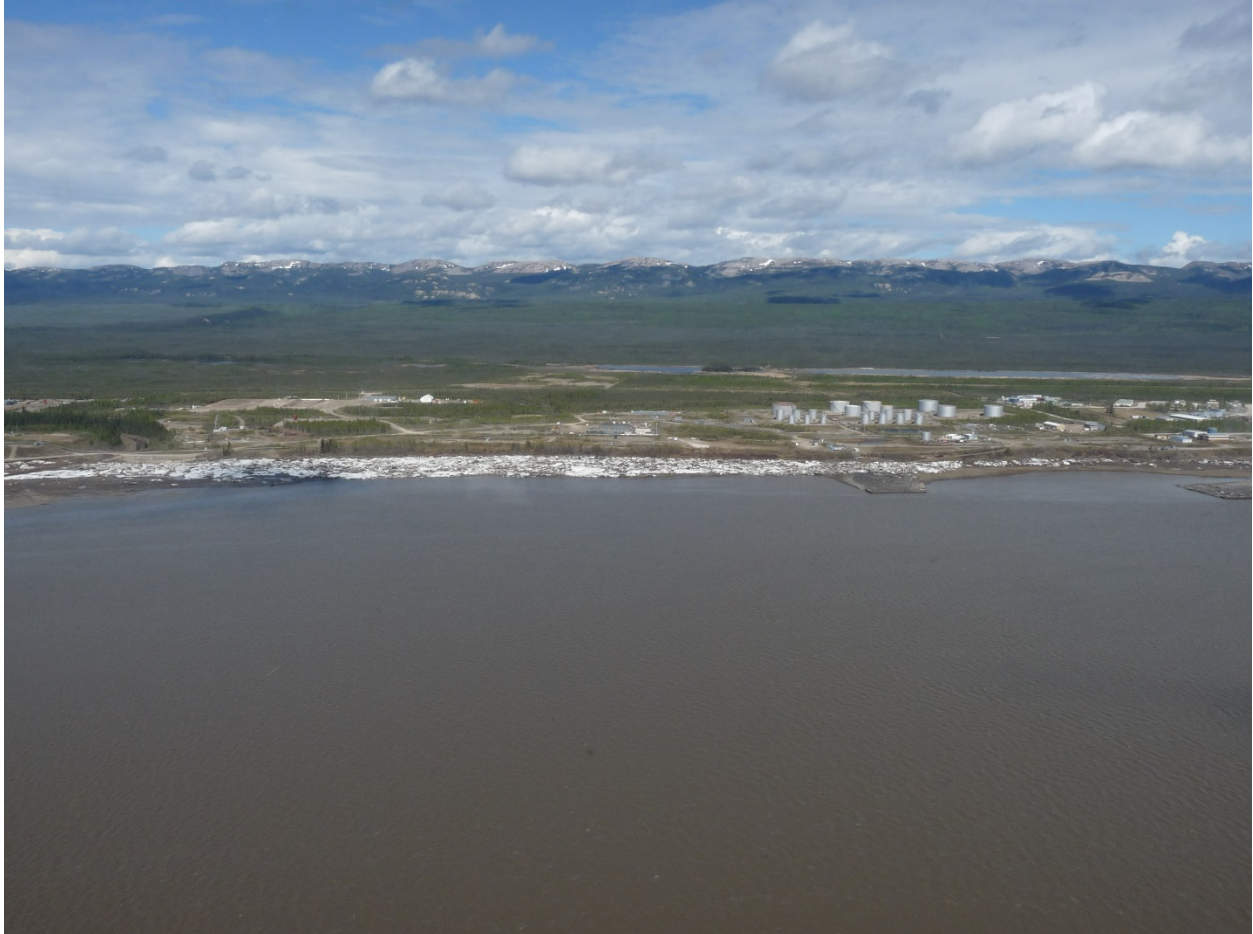
**Image A: Mainland Dock – May 23, 2017**

The inspection showed the mainland dock to be in good condition; therefore, no maintenance was required in 2017.

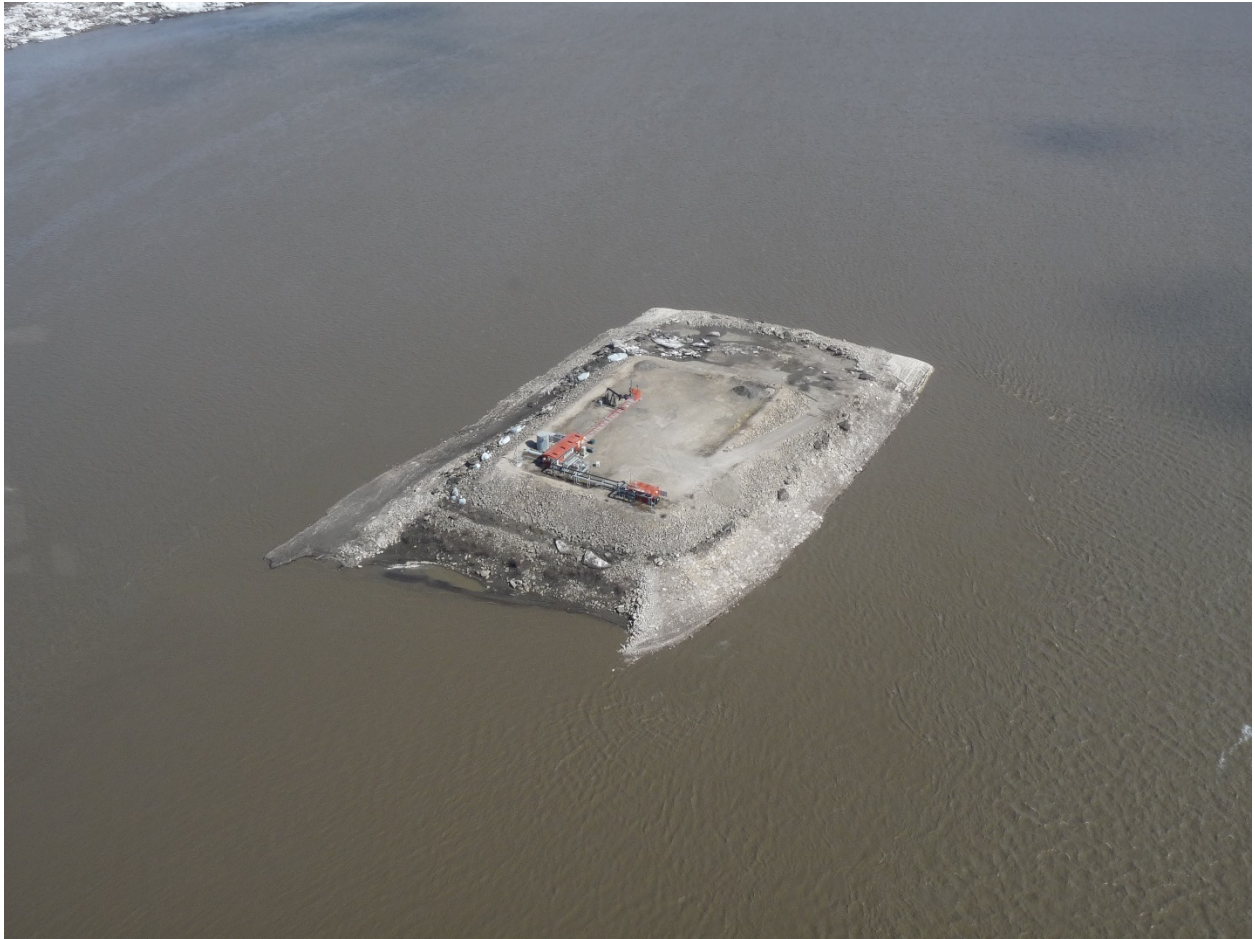
**Image B: Island 1 – May 23, 2017**

The inspection showed Island 1 to be in good condition; therefore, no maintenance was required in 2017

The inspection showed Island 1 to be in good condition; therefore, no repairs are required in 2017/2018 winter period.

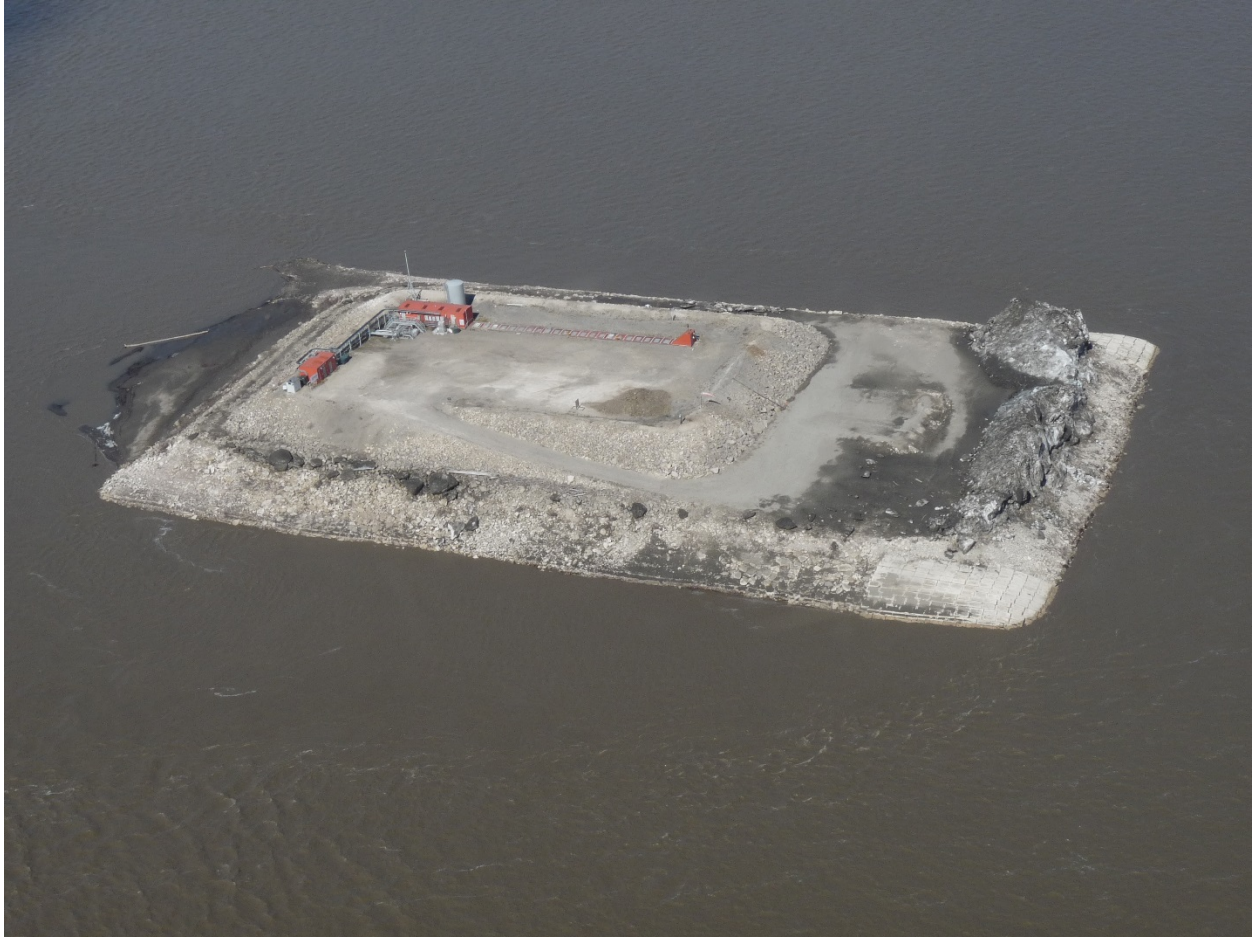
**Image C: Island 2 – May 23, 2017**

The inspection showed Island 2 to be in good condition; therefore, no maintenance was required in 2017

The inspection showed Island 2 to be in good condition; therefore, no repairs are required in 2017/2018 winter period.

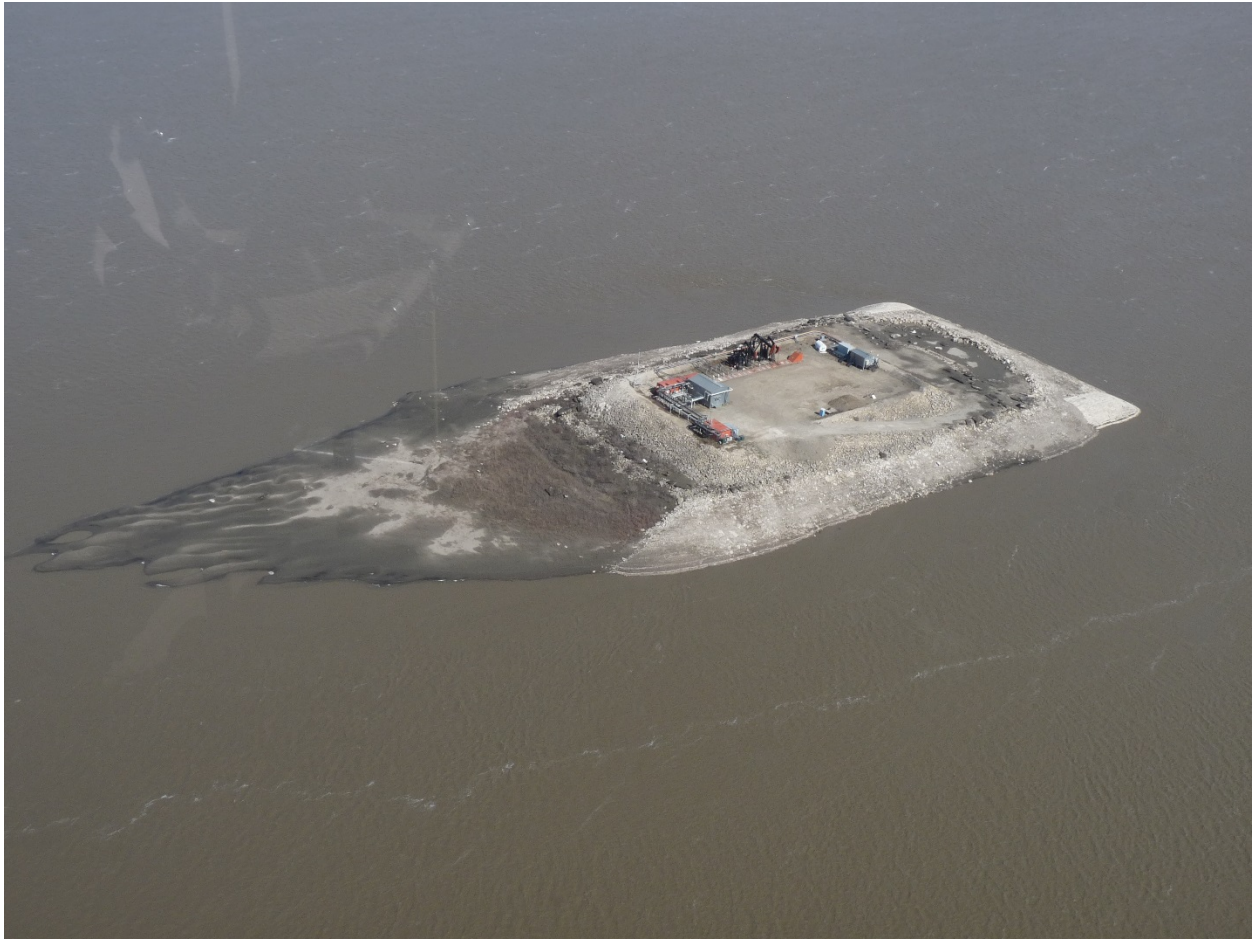
**Image D: Island 3 – May 23, 2017**

The inspection showed Island 3 to be in good condition; therefore, no maintenance was required in 2017.

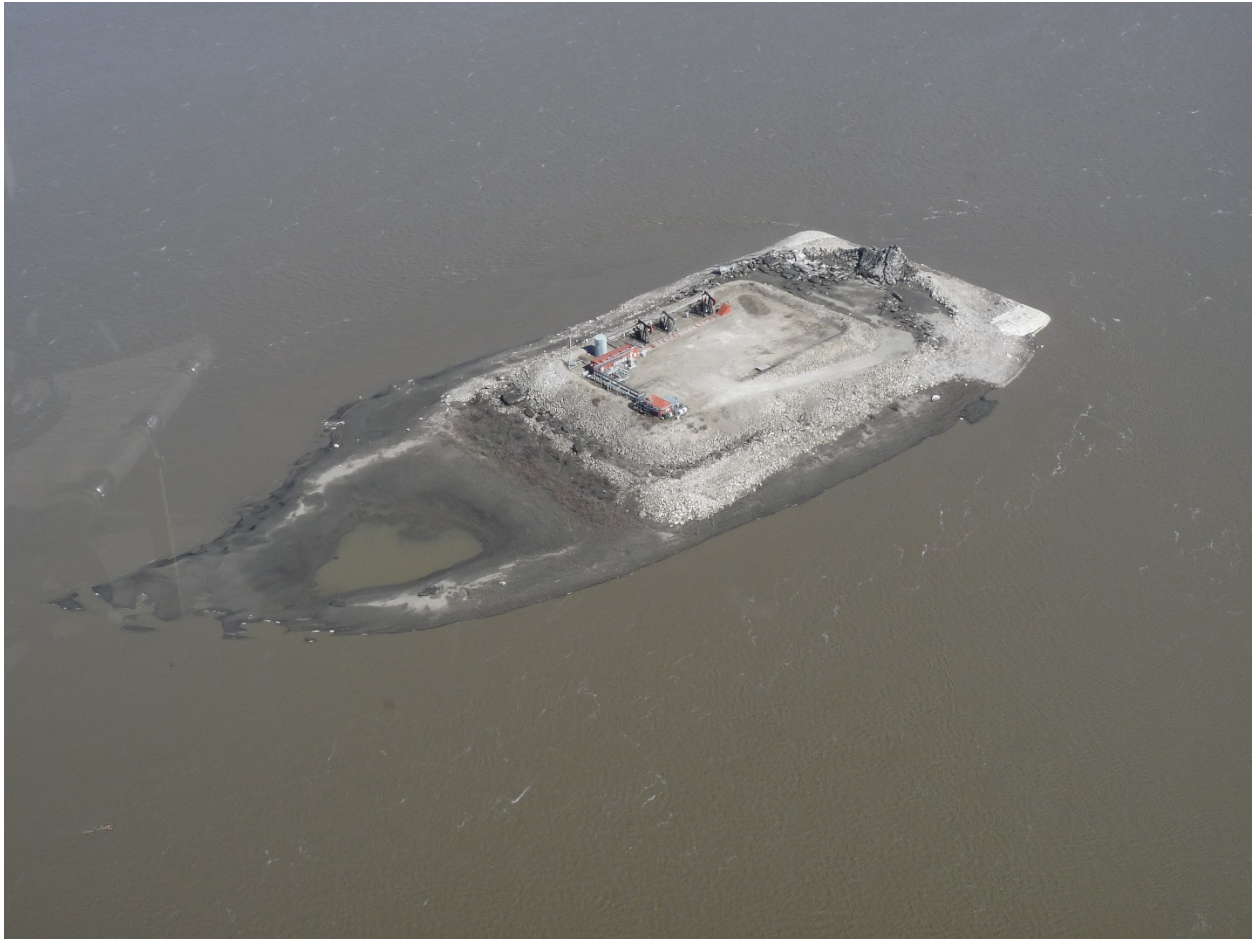
**Image E: Island 4 – May 23, 2017**

The inspection showed Island 4 to be in good condition; therefore, no maintenance was required in 2017

The inspection showed Island 4 to be in good condition; therefore, no repairs are required in 2017/2018 winter period.

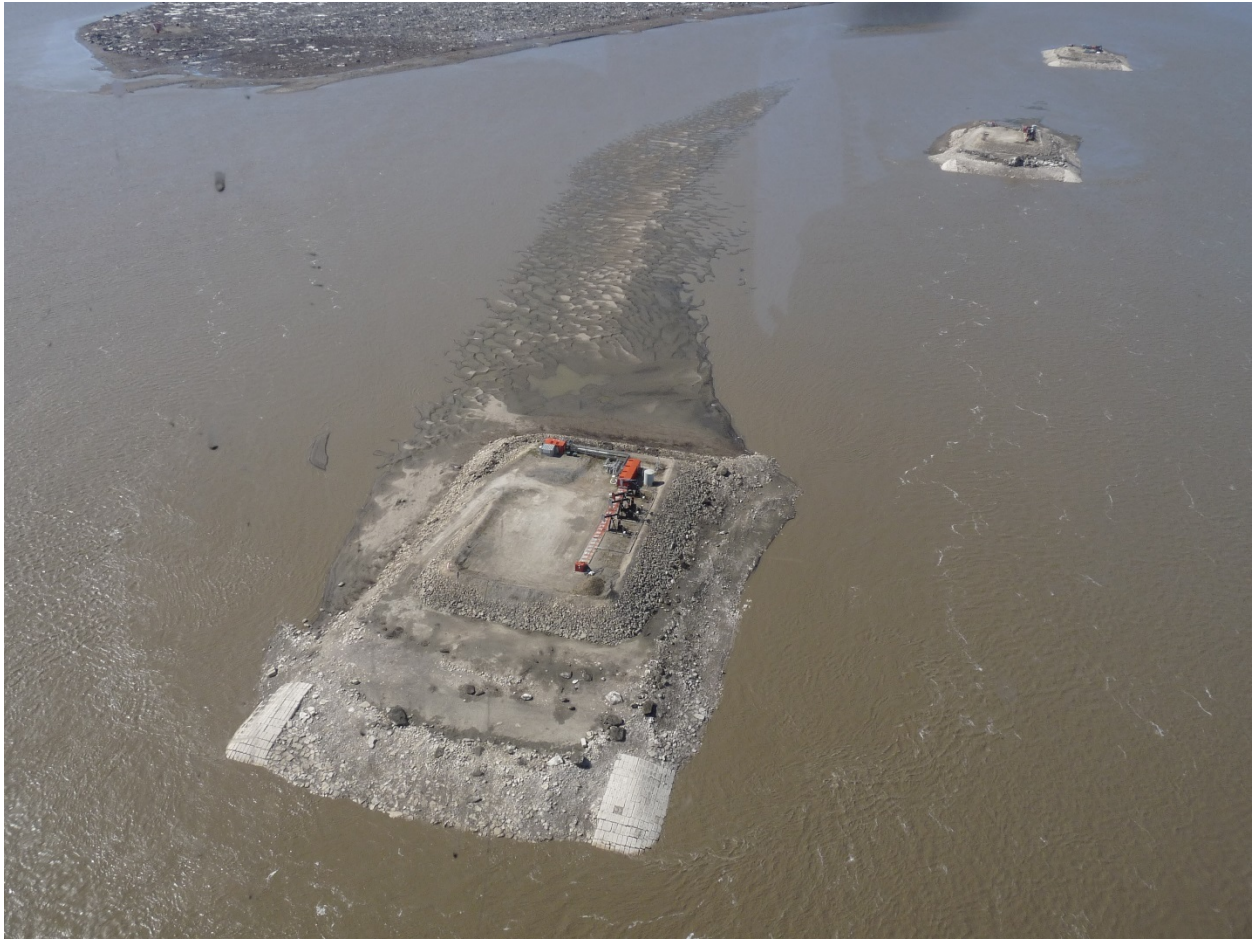
**Image F: Island 5 – May 23, 2017**

The inspection showed Island 5 to be in good condition; therefore, no maintenance was required in 2017.

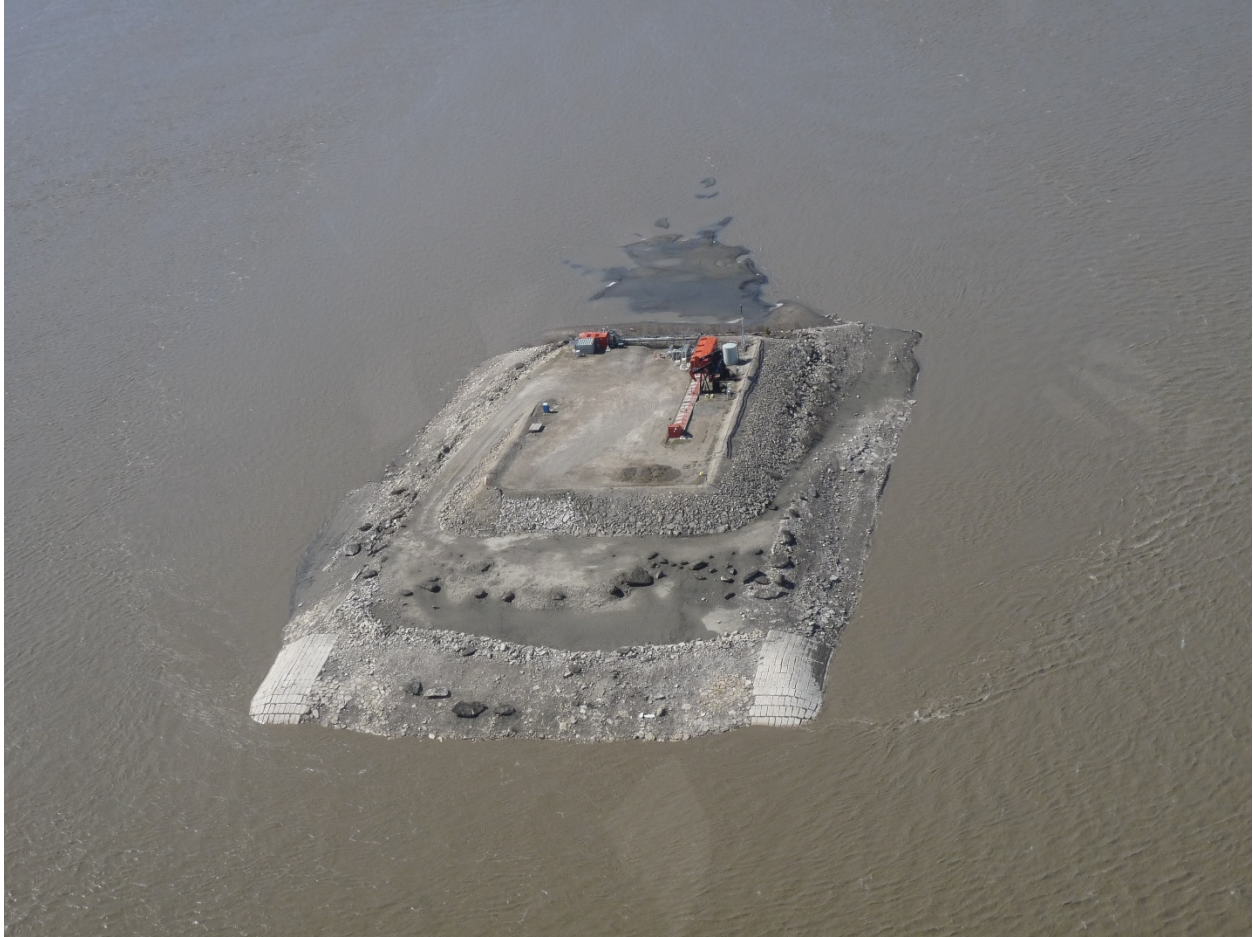
**Image G: Island 6 – May 23, 2017**

The inspection showed Island 6 to be in good condition; therefore, no repairs are required in 2017/2018 winter period.

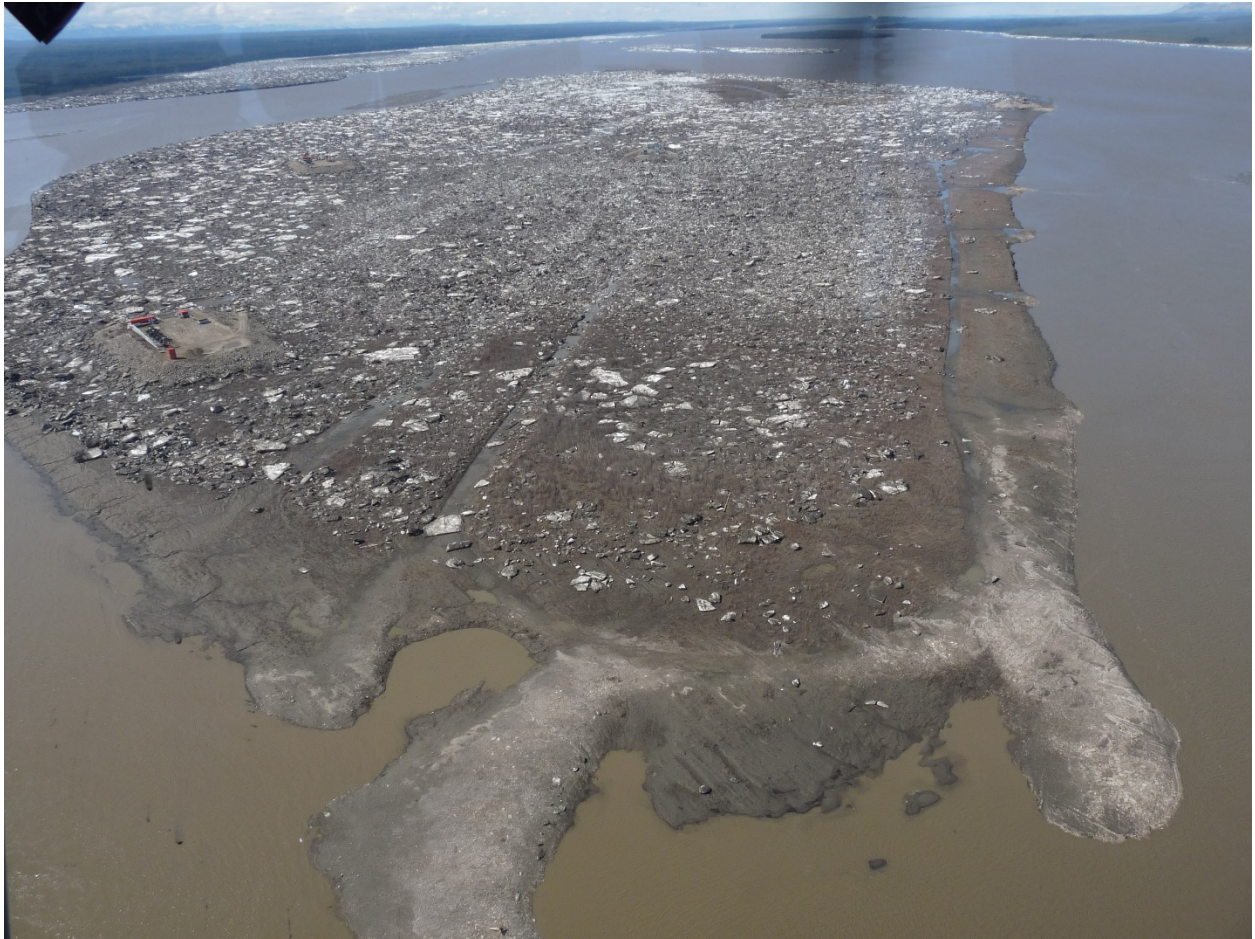
**Image H: Goose Island – May 23, 2017**

The inspection showed Goose Island Boat Landing to be in good condition; therefore, no maintenance was required in 2017.

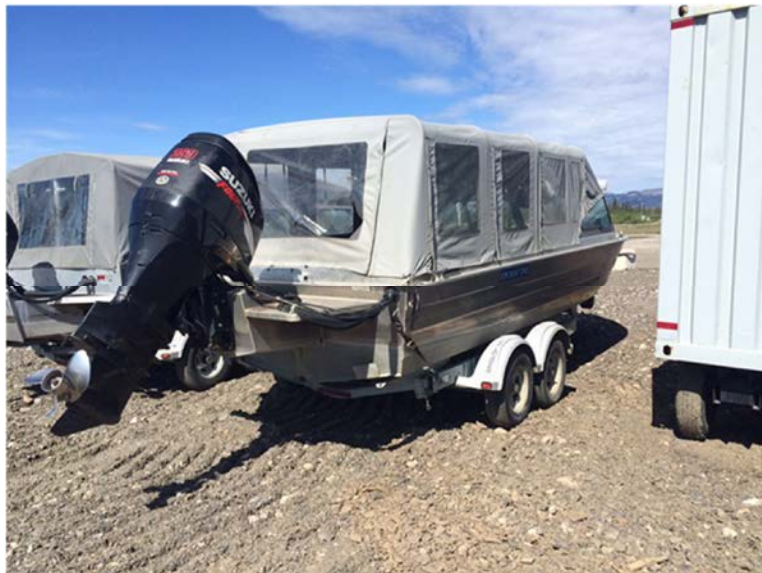
**Image J: Primary Survey Vessel (Imperial Boat 1)**

The survey launches and boat captains for this project were supplied by Imperial. The primary launch (Boat 1) is a 7.3 m aluminum vessel equipped with a 250 hp, 4 stroke Suzuki motor equipped with a propeller (Image J).

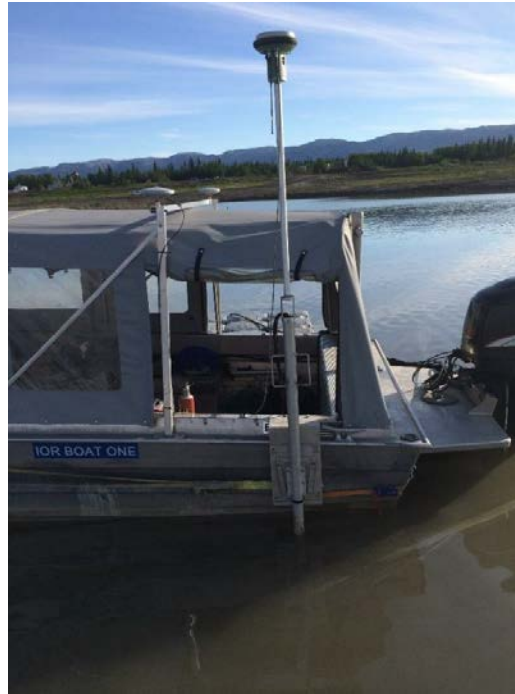
**Image K: Survey Gear**

The survey launch was equipped with the required survey gear and all instruments were interfaced into a central control platform running Hypack navigation and control software (Image K and L).

In 2016, the R2Sonic 2020 multibeam system was used for the bathymetric survey at Norman Wells. The high frequency of the R2Sonic 2020 allows for accurate and clean data. In order to accommodate the multibeam system a revised fixed mount was fabricated in 2015. Offsets for the bathymetric sensors including the multibeam, IMU, and GPS antennas were accurately measured using conventional survey technology.

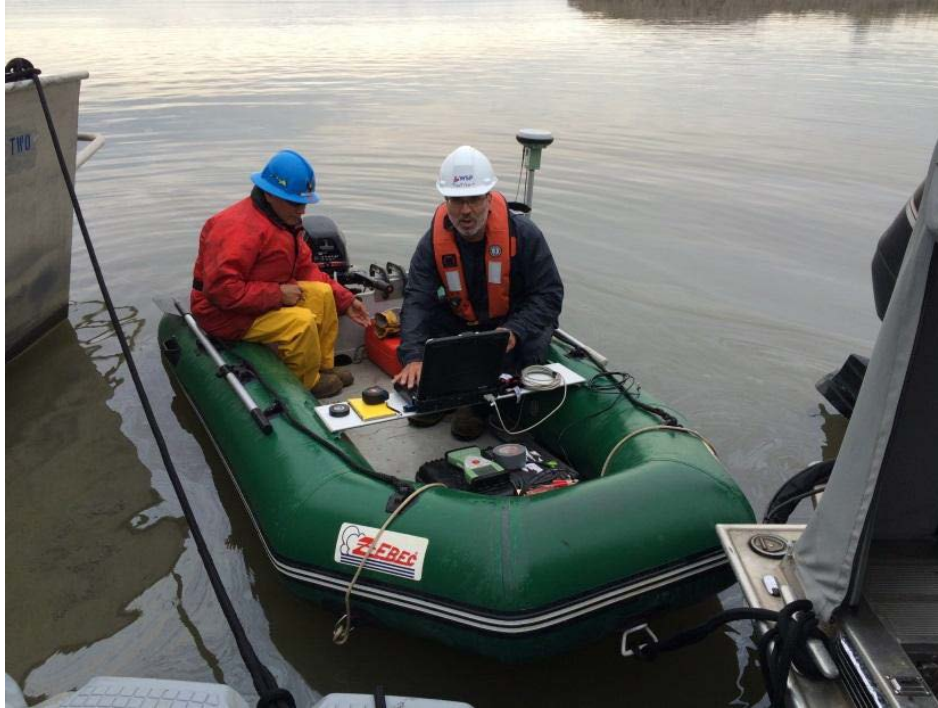
**Image M: 10.5' inflatable boat (Boat 2)**

In order to survey the river bottom in the shallower water areas between Goose Island, Artificial Islands 3 and 4, and between Bear Island and Island 6, a shallow draft 10.5' inflatable boat was used. The small light weight vessel was well suited for the task and easily transported the WSP crew, Imperial captain, and single beam echo sounder and RTK GPS (Image M).
