# Norman Wells Operations Annual Flowline Integrity and Break-Up Report

October 2020

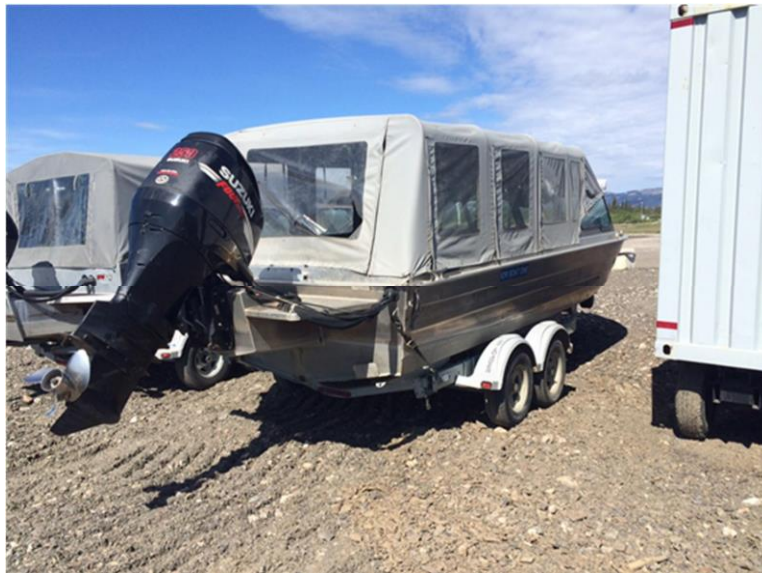
**Image A: Primary Survey Vessel (Imperial Boat 1)**

The survey launches and boat captains for this project were supplied by Imperial. The primary launch (Boat 1) is a 7.3 m aluminum vessel equipped with a 250 hp, 4 stroke Suzuki motor equipped with a propeller (Image A).
